MICROSCOPIC EXAMINATION OF STEEL

HENRY FAY, Ph. D., D. Sc.

Professor of Analytical Chemistry, Massachusetts Institute of Technology
Consulting Metallurgist, Watertown Arsenal

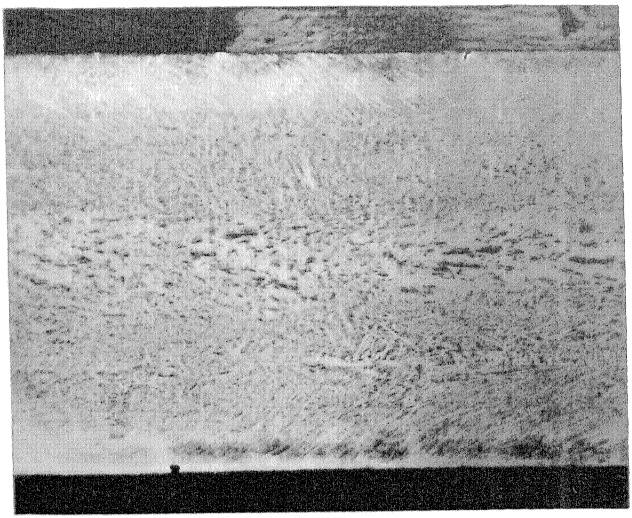
PHOTOGRAPH NO. 19. ONE-THIRD SIZE.
Ingot structure in steel.

The presence of ingot structure such as shown in photograph No. 19 indicates that the heat treatment and forging have not been sufficient to wipe out the crystallization which occurred on the solidification of the metal. It is not definitely known that the presence of ingot structure is harmful, and it is frequently accompanied by excellent microstructure, but it serves as an indication of the heat treatment to which the metal has been subjected after solidification. It is believed that such a structure would not be found in the best steel, and it is further believed that metal showing ingot structure would be more liable to rupture from shock than metal in which the ingot structure had been wiped out by heat treatment and forging.

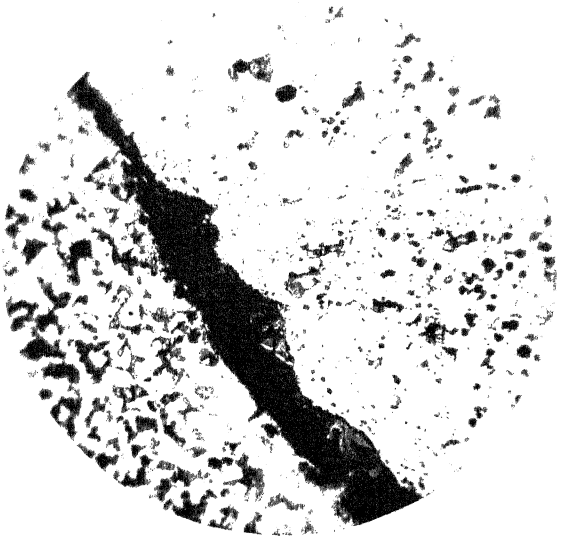
PHOTOGRAPH NO. 24. X50.

The inclusion of oxide is frequently accompanied by partial decarbonization, and is most frequently found on or near the surface. An example of this is shown in photograph No. 24, in which it is seen that a crack has penetrated through the slag, probably mill scale, and in the crack are the remnants of the slag. On the left of the crack is the normal structure and on the right is a decarbonized area containing slag. Such an area would probably be large enough to show to the naked eye and would be considered unsafe. Other examples of oxide inclosures are cited on pages 14 and 15, in the discussion of the failure of 10-inch gun and 14-inch gun lever.

Crack, slag, and decarbonized area found on the base of a steel rail.

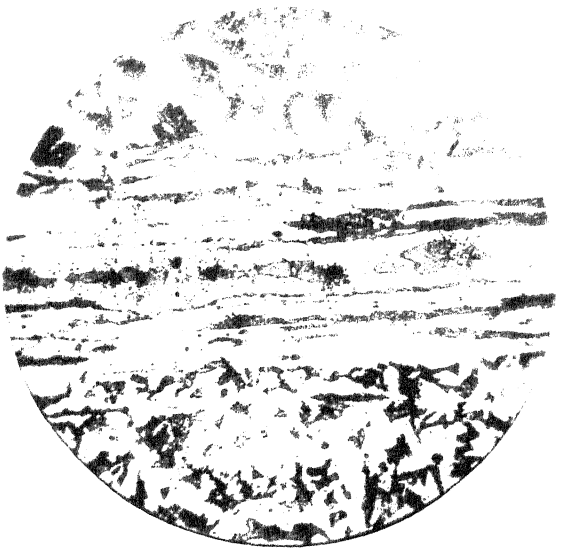
PHOTOGRAPH NO. 27. X50.

Microstructure of light-colored streak in No. 26.

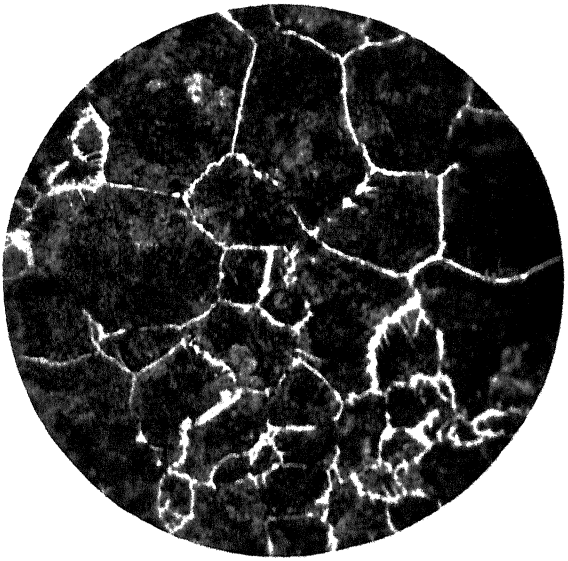
PHOTOGRAPH NO. 30. X75.

Coarse microstructure in gun steel.

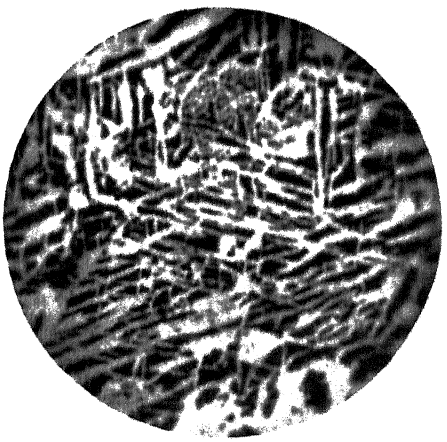
PHOTOGRAPH NO. 31. X50.

Crystalline structure in cast steel.

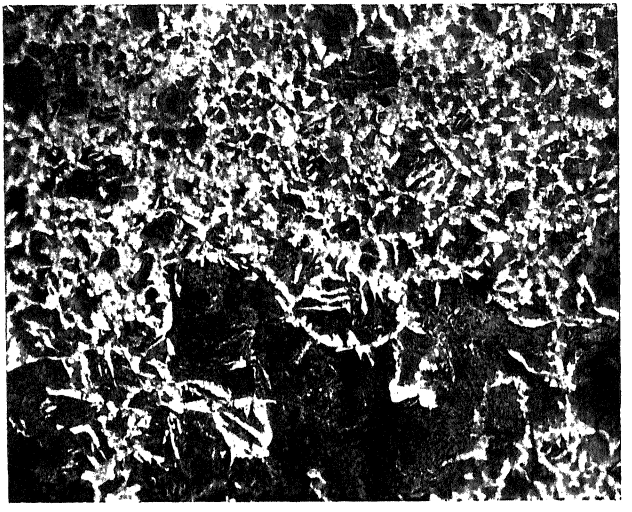
PHOTOGRAPH NO. 32. X75.

Failure to obtain uniformity of structure is shown in photograph No. 32. Discussion of photographs Nos. 49, 51, and 53 will be found under the discussion of some of the special cases, viz., the failure of 14-inch gun lever arm. Dangerous overheating is shown in photograph No. 33. In this case the material is burnt, as is shown by the oxide between the granules of pearlite.

Microstructure showing incomplete heat treatment.

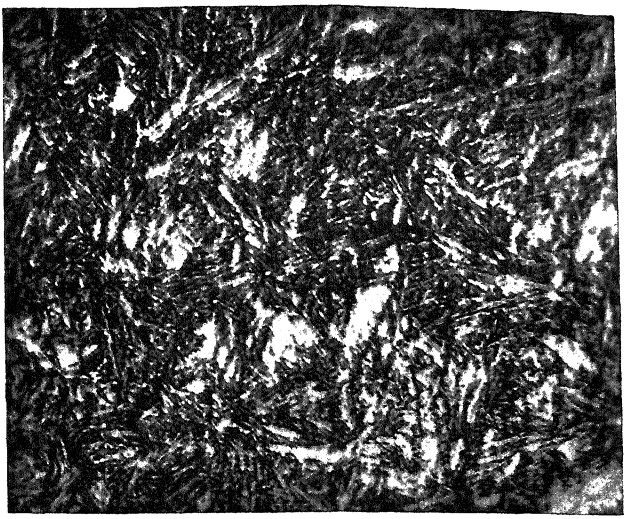
PHOTOGRAPH NO. 34. X500.

observed that the original martensitic structure is completely removed by the tempering process. This point is illustrated by photograph No. 34 in which there are distinct remains of the original martensitic structure. Such a steel properly heat treated ought to show a structure similar to photographs Nos. 12 or 13.

Microstructure of forging which had been originally martensitic, and in tempering this structure has not been completely eliminated.

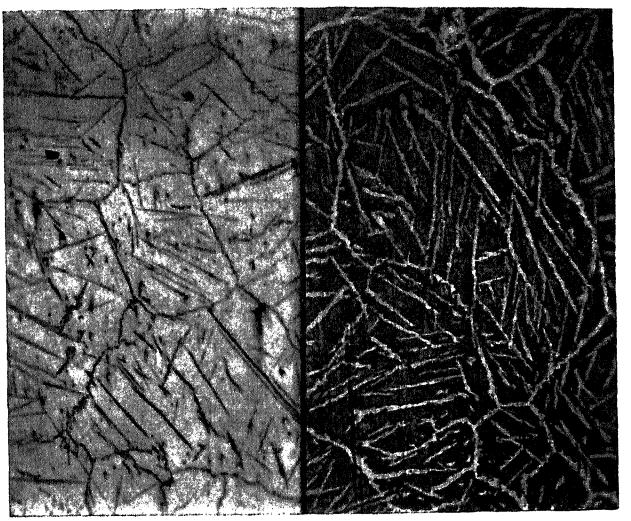
PHOTOGRAPH NO. 35. X65.

Microstructure in center of broken recoil spring showing excess cementite, indicating high carbon. Left, white lines are cementite etched with nitric acid solution; right, dark lines are cementite etched with sodium picrate solution.

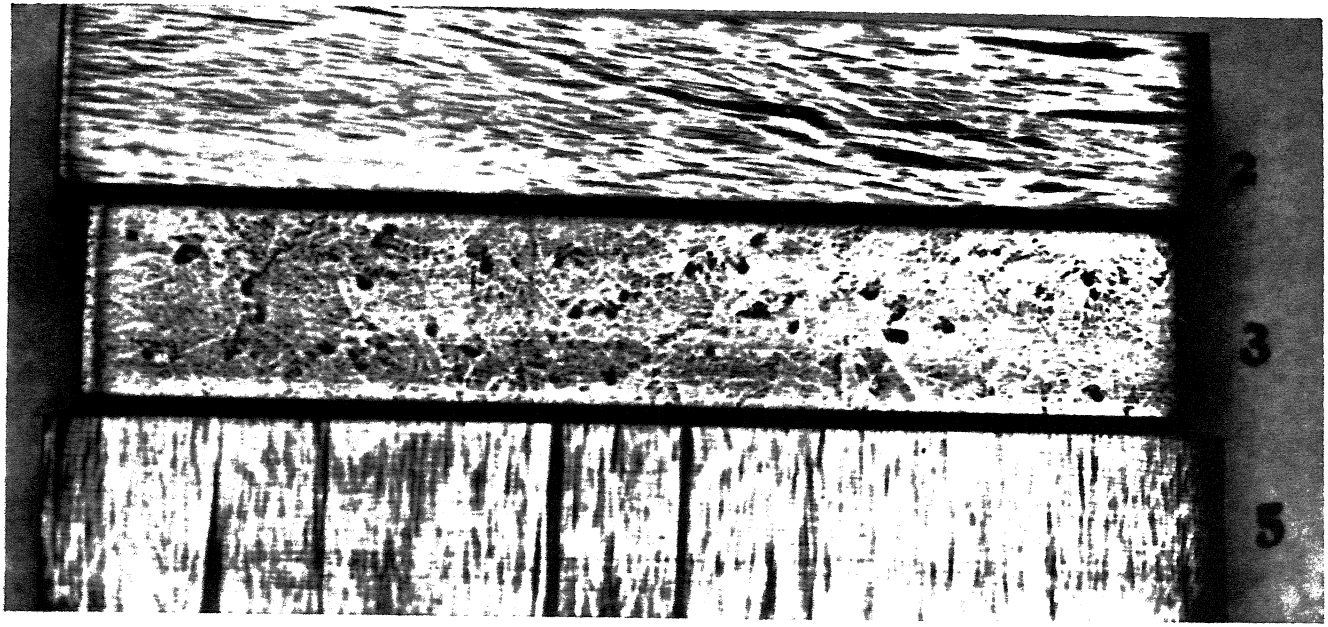
PHOTOGRAPH NO. 38.

Photographs Nos. 38 and 39 show the macrostruct
steel when etched with iodine, the specimens shown
graph No. 38 being taken longitudinally, radially, a
tially. The segregation of phosphorus is indicated b
lines in pieces Nos. 2 and 5 of photograph No. 38 a
pieces of photograph No. 39 and by the dark spots in
3. Photograph No. 39 shows the metal cut from th
the fracture and treated in the same manner, as sho
piece marked 5 in photograph No. 38, and in other
not shown. The dark streaks were found to be elong
lel to the direction of forging, and it is reasonable
that the elongation will always be parallel to the sur
forged. By inspection of the two larger pieces of meta
the region of the crack (photograph No. 39) it will be
there is considerable distortion of the phosphide area

Macrostructure of test bars of 10-inch pipe showing surfaces cut longitudinal 5, radial 3, and tangential 2 to axis.

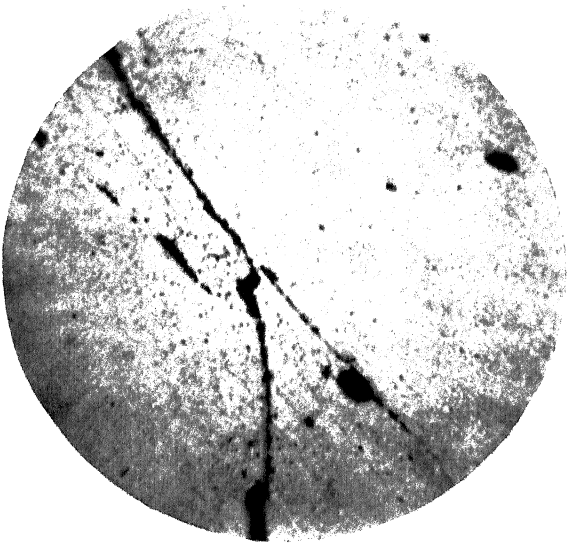
PHOTOGRAPH NO. 41. X50.

Examination of sections in the vicinity of the crack showed many fine cracks, slag inclusions, and carbonless areas. The cracks led to slag, and where the slag was found there were also found decarbonized areas. Photograph No. 40 shows a crack ending in slag and surrounded by decarbonized iron. The course of the slag was quite irregular, as shown in photographs Nos. 41 and 42.

It is believed that the crack in this gun was caused by folding in of some of the metal during forging. Incidentally some other defects are pointed out.

Slag in 10-inch rifle, unetched.

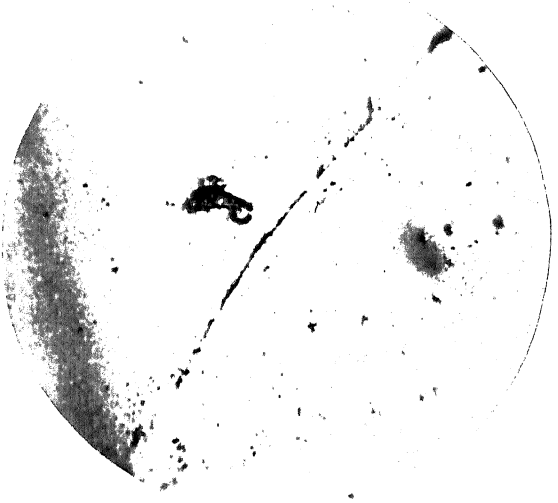
PHOTOGRAPH NO. 42. X50.

Slag in 10-inch rifle, unetched.

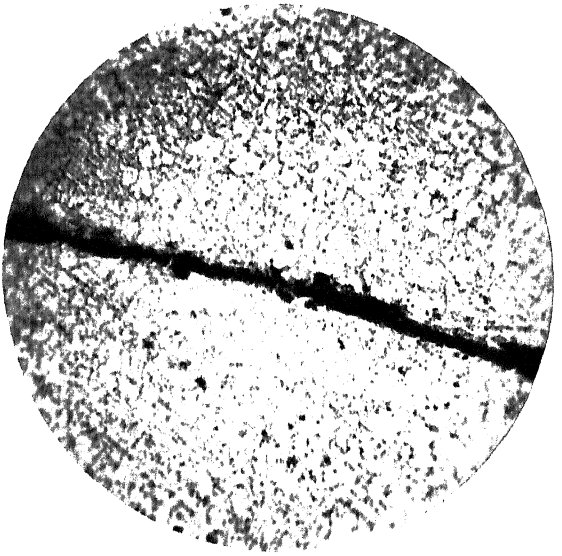
PHOTOGRAPH NO. 43. X50.

That the slag originated and was folded into the metal during the process of forging rather than during the manufacture of the steel is indicated by the fact that it is strongly oxidizing in character. If it had originated at the time of making the steel, and had then burned out some of the carbon, there would still have been plenty of time for more carbon to have diffused back into these areas. It is found here, however, surrounded by free ferrite along the slag lines, as shown in photograph No. 43 and in photograph No. 44, in which is shown an isolated slag spot surrounded by free ferrite, and this in turn by the normal structure.

Slag and decarbonized area in 10-inch rifle.

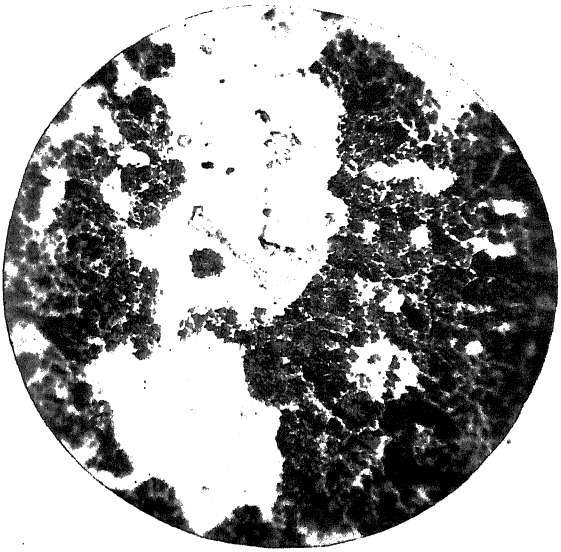
PHOTOGRAPH NO. 46. X50.

This lever was made of cast steel and was broken during the test of the carriage. A microscopic examination revealed the structures shown in photographs Nos. 46 to 51, inclusive.

Fourteen-inch gun lever. Segregated ferrite (white) with slag inclosures.

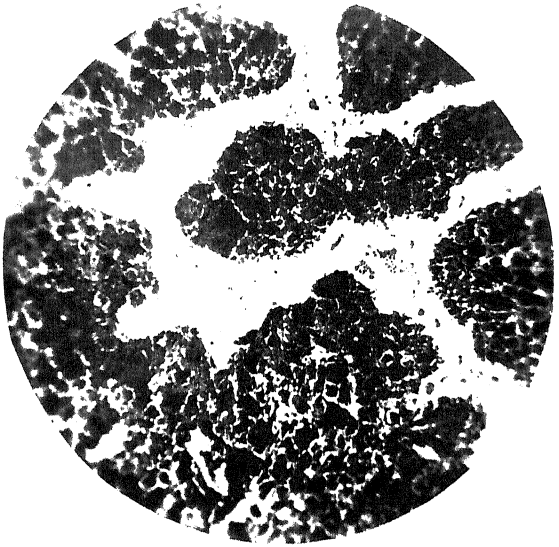
PHOTOGRAPH NO. 48. X50.

In the fractured ends of the test pieces the metal shows decidedly bright spots, and these are due, it is believed, to the presence of the segregated ferrite. Further, it has been noticed that along the stem of the test pieces incipient cracks are developed, as shown in photograph No. 45. It is highly probable that these incipient fractures are developed in such areas as shown in photograph No. 47, which shows a large ferrite field at the edge of the specimen. It is possible that if the forces are transmitted equally throughout the test piece that such a portion would yield more readily where the carbon was lowest. The strength of such a spot would be approximately that of pure iron, or about 40,000 pounds per square inch, while the darker areas which contain more carbon would show considerably higher values. The presence of much slag in the ferrite areas would also increase the brittleness at this point, and would account for the low ductility in some specimens. Further examples of this form of segregation are shown in photographs Nos. 48 and 49.

Fourteen-inch gun lever. Segregated ferrite (white) with slag inclusions.

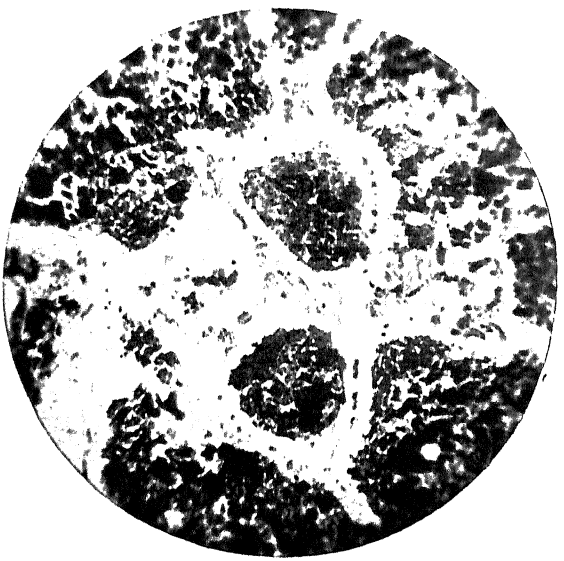
PHOTOGRAPH NO. 49. X50.

Fourteen-inch gun lever. Segregated ferrite with slag inclusions.

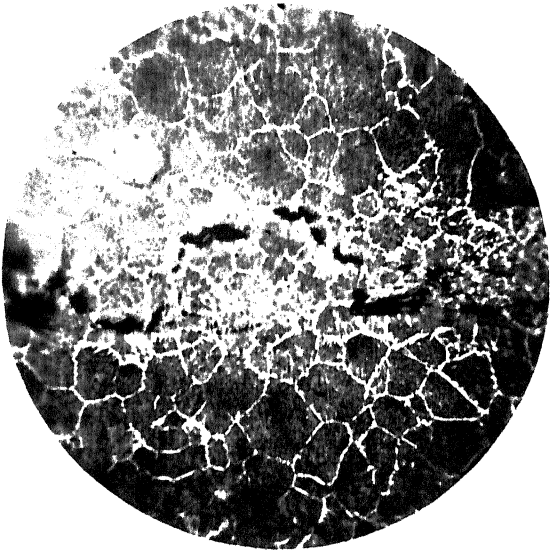
PHOTOGRAPH NO. 53. X50.

The cause of rupture is believed to have been due to the presence of a zone of streaked metal, and further, that this resulted from the presence of slag in the original ingot.

Twelve-inch gun. Microstructure showing slag and fissures.

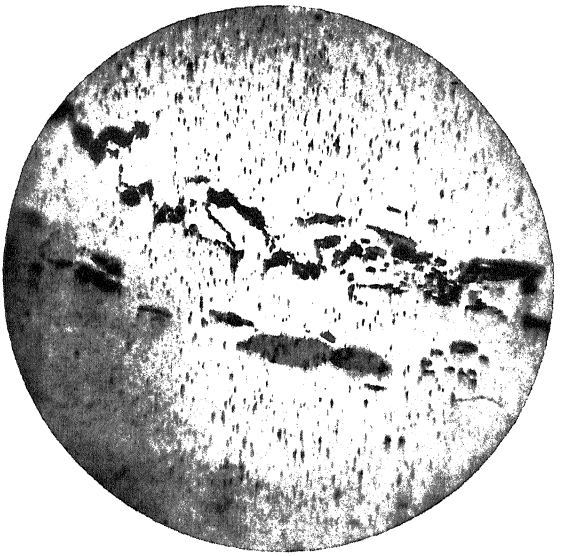
PHOTOGRAPH NO. 54. X50.

Twelve-inch gun. Slag in unetched specimen.

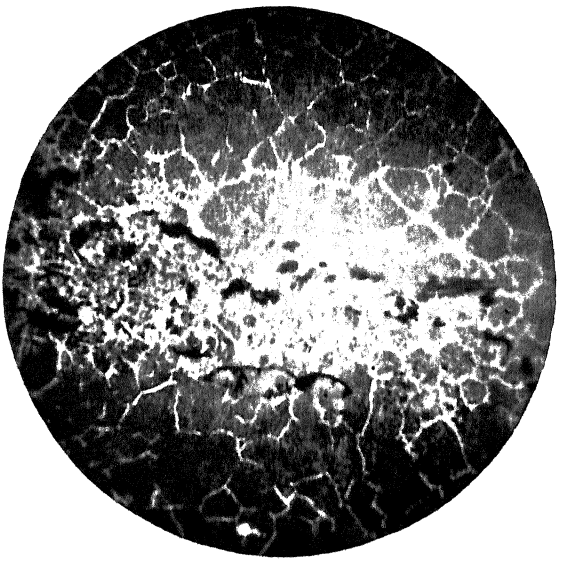
PHOTOGRAPH NO. 55. X50.

Twelve-inch gun. Same area as No. 54, etched with alcoholic nitric acid.
